MICROSCOPIC INTERNAL FLAWS INDUCING FRACTURE IN STEEL.

THOMAS ANDREWS, F.R.S., F.C.S., M. Inst. C.E.

From "ENGINEERING," July 10, 17 and 24, 1896.

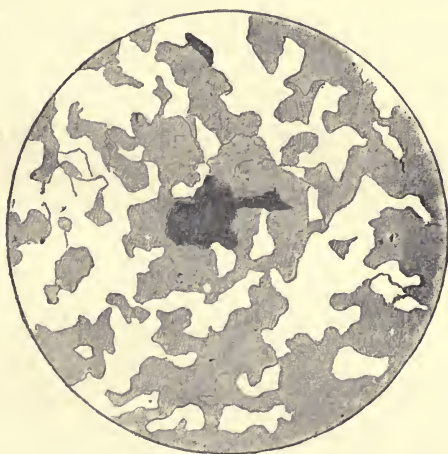
FIG. 3. Internal Sulphur Flaws $\times 300$ diameter.

FIG. 4. Bessemer Steel Railway Axle, showing Internal Micro-Flaws $\times 500$ diameter.

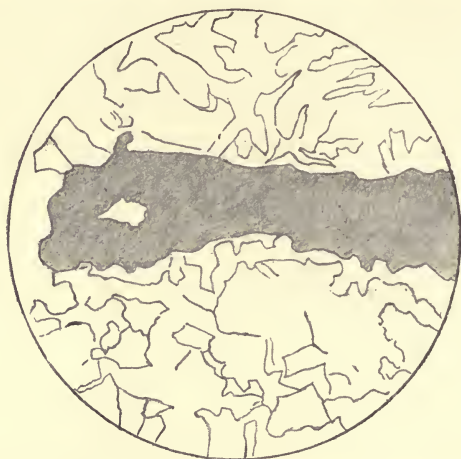
FIG. 5. Internal Flaw $\times 300$ diameter, Bessemer Steel Railway Axle 2.

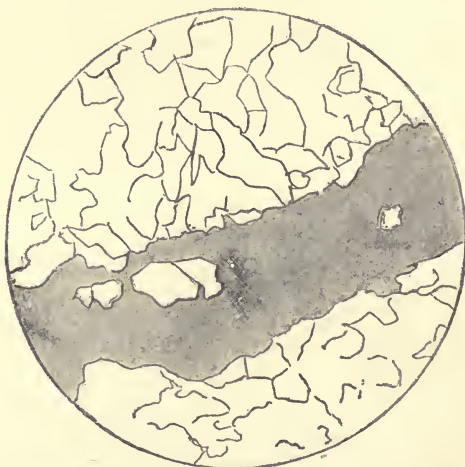
FIG. 6. Bessemer Steel Railway Axle, Internal Flaw $\times 300$ diameter.

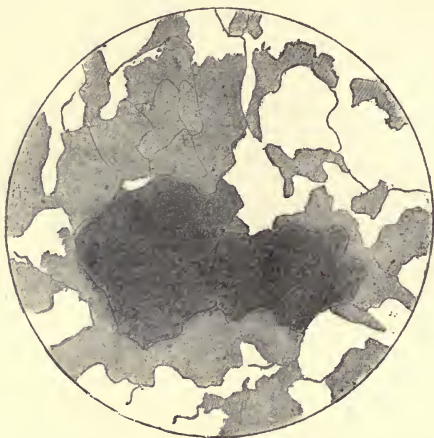
FIG. 9. Siemens Steel (W.S.) Railway Axle, Internal Micro-Flaws, $\times 300$ diameter.

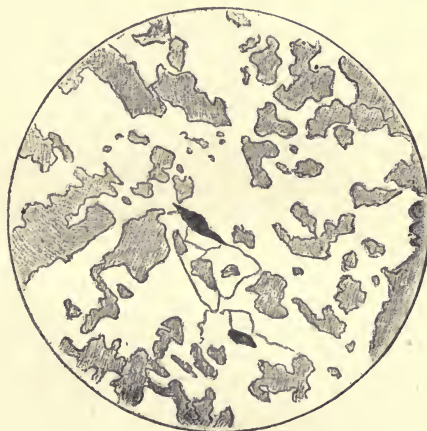
FIG. 12. Siemens Steel Locomotive Crank Axle, showing Internal Micro-Flaws, $\times 300$ diameter.

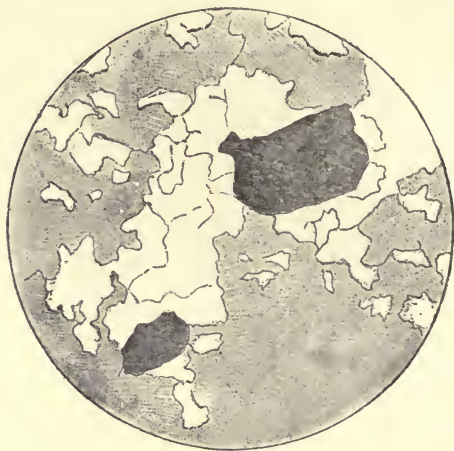
FIG. 13. English Bessemer Steel Railway Tyre, Internal Micro-Flaws, $\times 400$ diam.

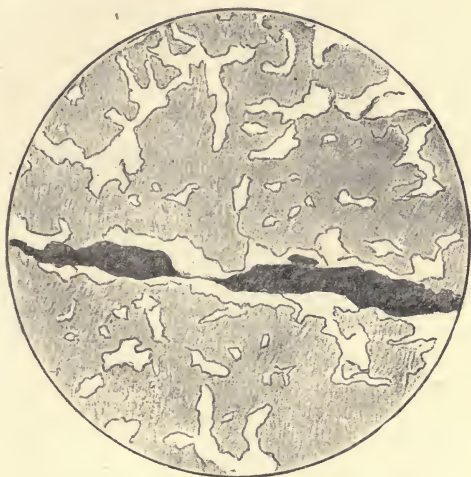
FIG. 15. Bessemer Steel Rail, 86 lb. per yard, showing Internal Micro-Flaws, $\times 300$ diameter.

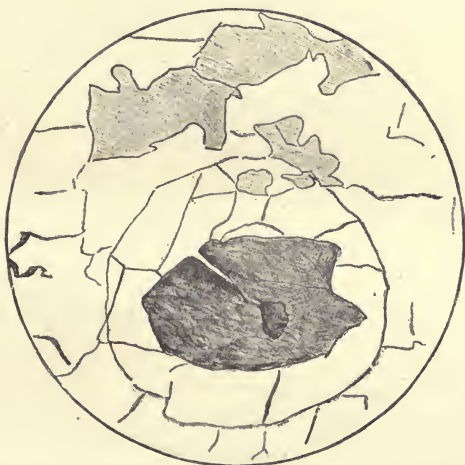
FIG. 16. Siemens Steel Propeller Shaft, Internal Micro-Flaw, $\times 500$ diameter.

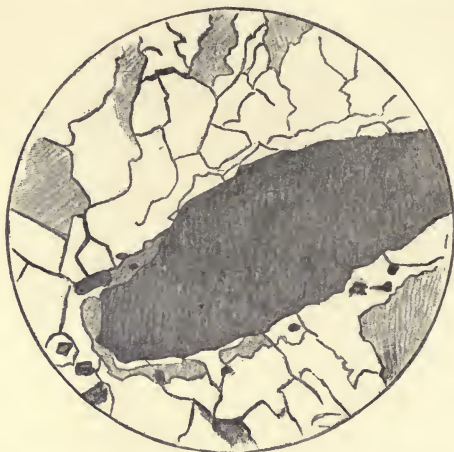
FIG. 17. Internal Micro-Flaw, Siemens Steel Propeller Shaft, $\times 300$ diameter.

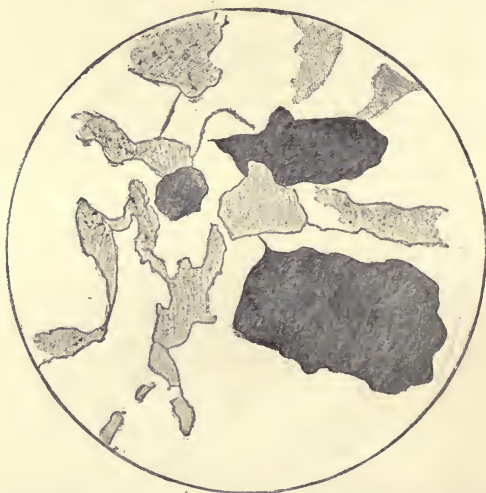
FIG. 18. Internal Micro-Flaws, Siemens Steel Propeller Shaft, $\times 800$ diameter.

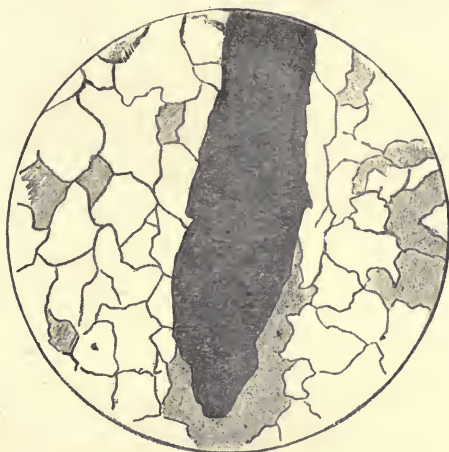
FIG. 19. Internal Micro-Flaw, Siemens Steel (Warship) Propeller Shaft, $\times 300$ diam.

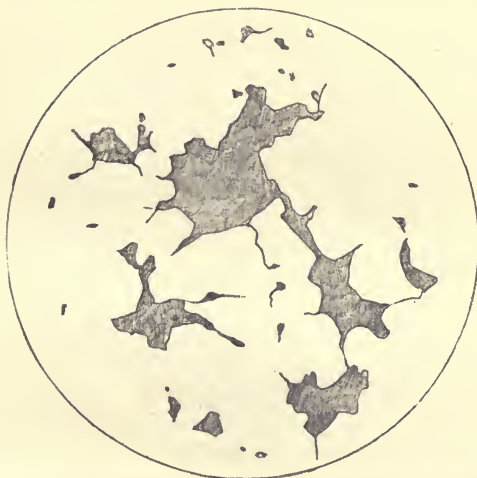
FIG. 22. Internal Micro-Flaws, Siemens (soft) Steel Shaft, $\times 300$ diameter.

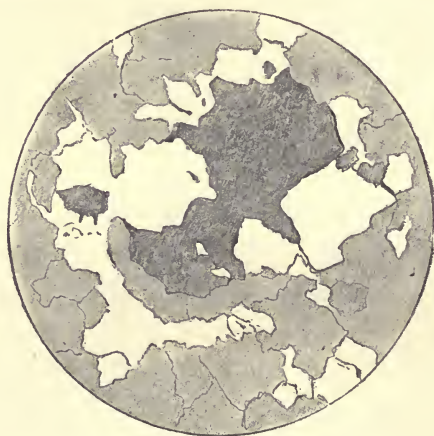
FIG. 24. Siemens (hard) Steel Shaft, Internal Micro-Flaws, $\times 300$ diameter.

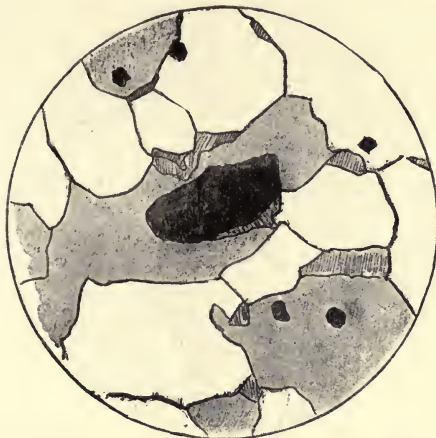
FIG. 25. Internal Micro-Flaws, Bessemer (soft) Steel Shaft (rolled), $\times 500$ diam.

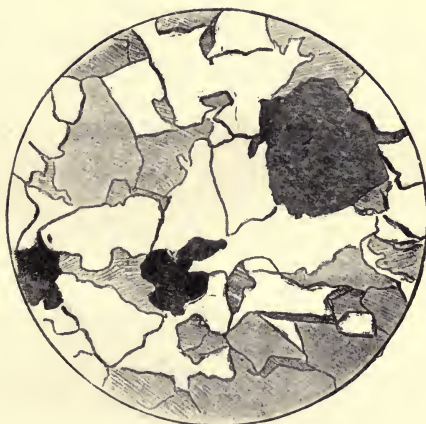
FIG. 26. Internal Micro-Flaws, Nickel Steel Shaft, $\times 500$ diameter.

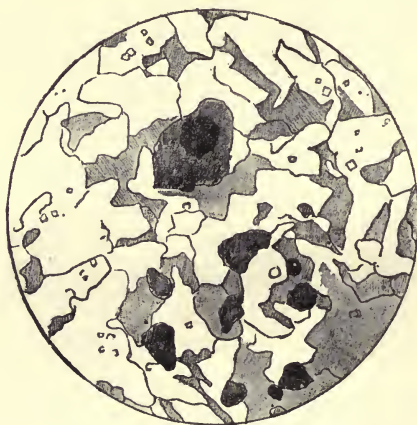
FIG. 28. Silicon Steel Shaft, Internal Micro-Flaws, $\times 300$ diameter.

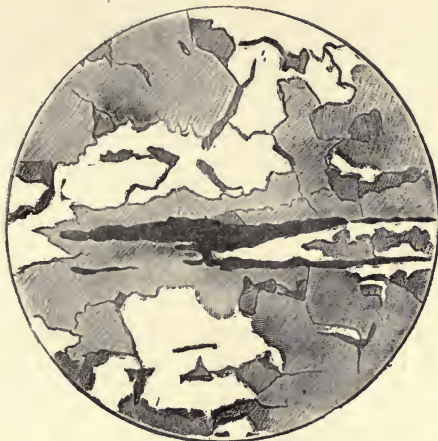
FIG. 29. Internal Micro-Flaws, Siemens Steel Ship-plate, $\times 300$ diameter.
